Cultural Resource Survey
Property Identification Form

1. Name of Property: Messick Cemetery (Tax Parcel 1-34-12-9.00)
2. Street Location: North side of Route 26, west of Holt Lane
3. Owner's Name: Messick Cemetery Tel. #: _____
Address: RD 26, Millville, DE 19970
4. Type of Resource(s): building: ☐ structure: ☐ site: ☒
 object: ☐ district: ☐
5. Surroundings: (check more than one, if necessary)
- fallow field: ☐ cultivated field: ☐ woodland: ☐
 scattered buildings: ☐ structure: ☐ site: ☒
6. Function: original Cemetery present Cemetery
7. List Additional Forms Used:
Landscape Documentation Form (CRS-8)

1. Name of Property: Franklin and Diane Bennett Property (Tax Parcel 1-34-12-338.00)
2. Street Location: South of Route 26, west of Road 347
3. Owner's Name: Franklin and Diane Bennet Tel. #: _____
Address: P.O. Box 369, Ocean View, DE 19970
4. Type of Resource(s): building: ☒ structure: ☐ site: ☐
 object: ☐ district: ☐
5. Surroundings: (check more than one, if necessary)
- fallow field: ☐ cultivated field: ☐ woodland: ☐
 scattered buildings: ☒ structure: ☐ site: ☐
6. Function: original Residence present Residence
7. List Additional Forms Used:
Main Building Form (CRS-2)
Related Outb

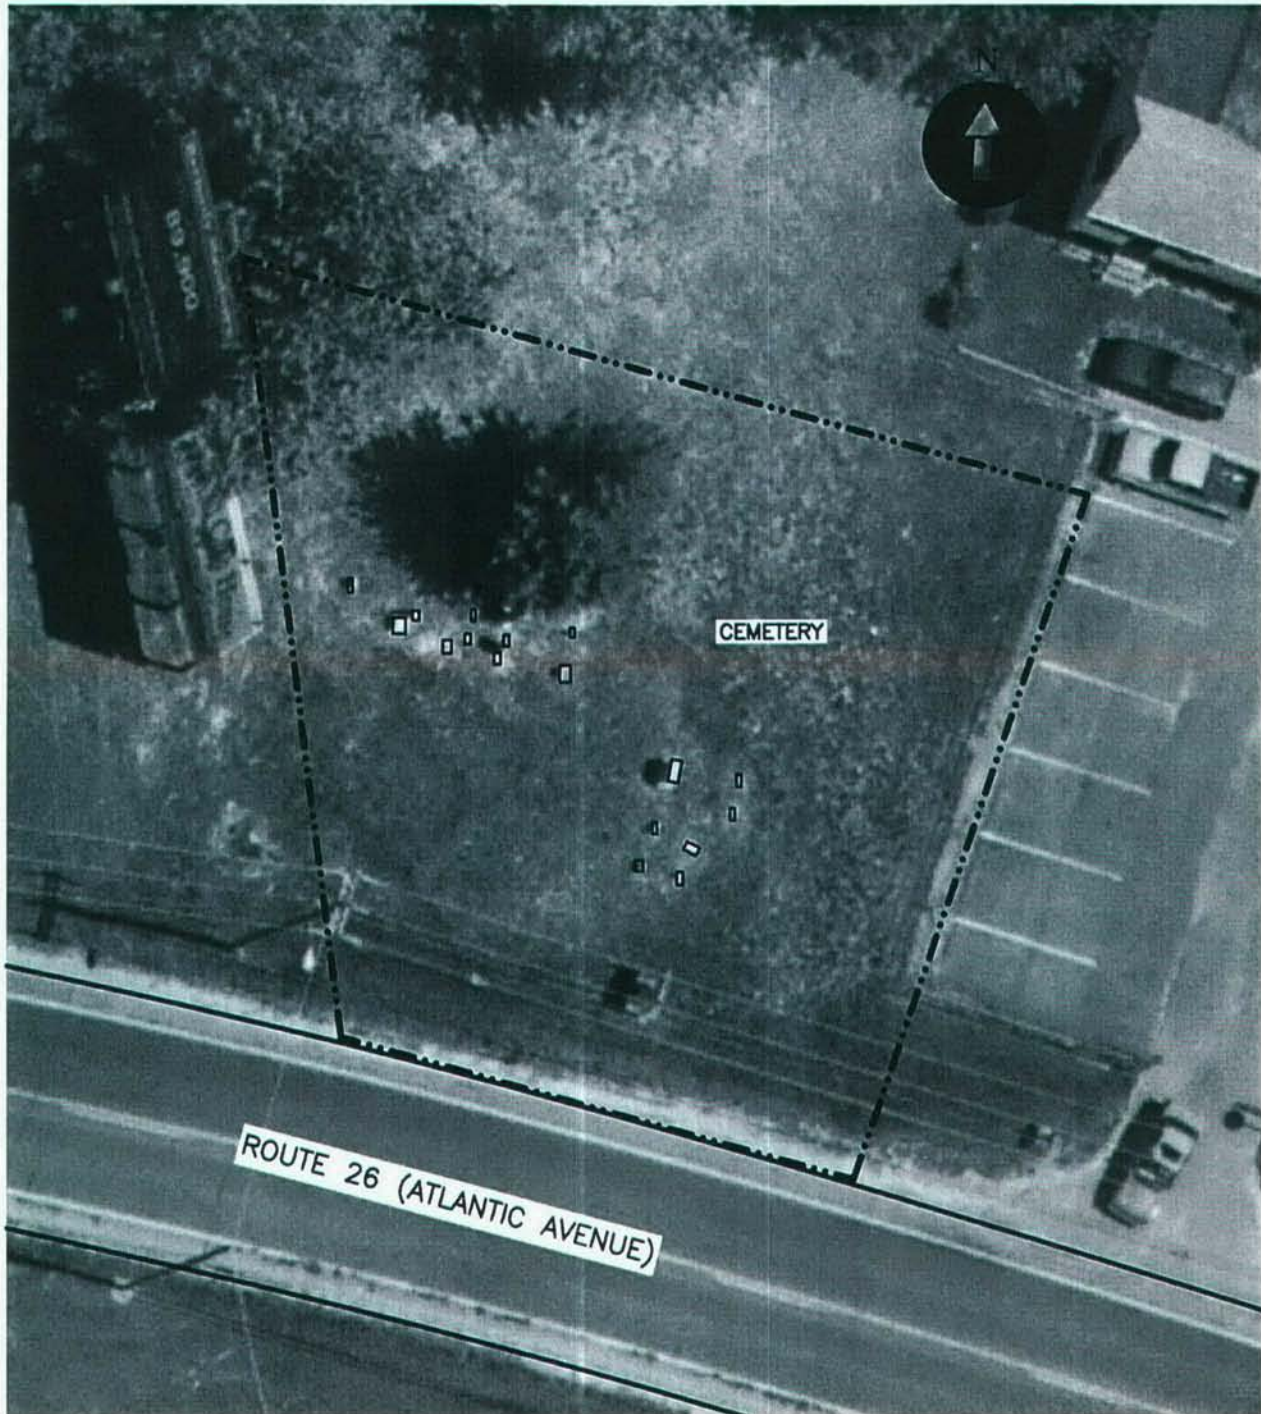
Sketch Plan:

Within a few feet north of the edge of road lies a small collection of graves in the Messick Cemetery (Tax Parcel 1-34-12-9.00). Small headstones mark the graves. Grass covers the parcel of land.

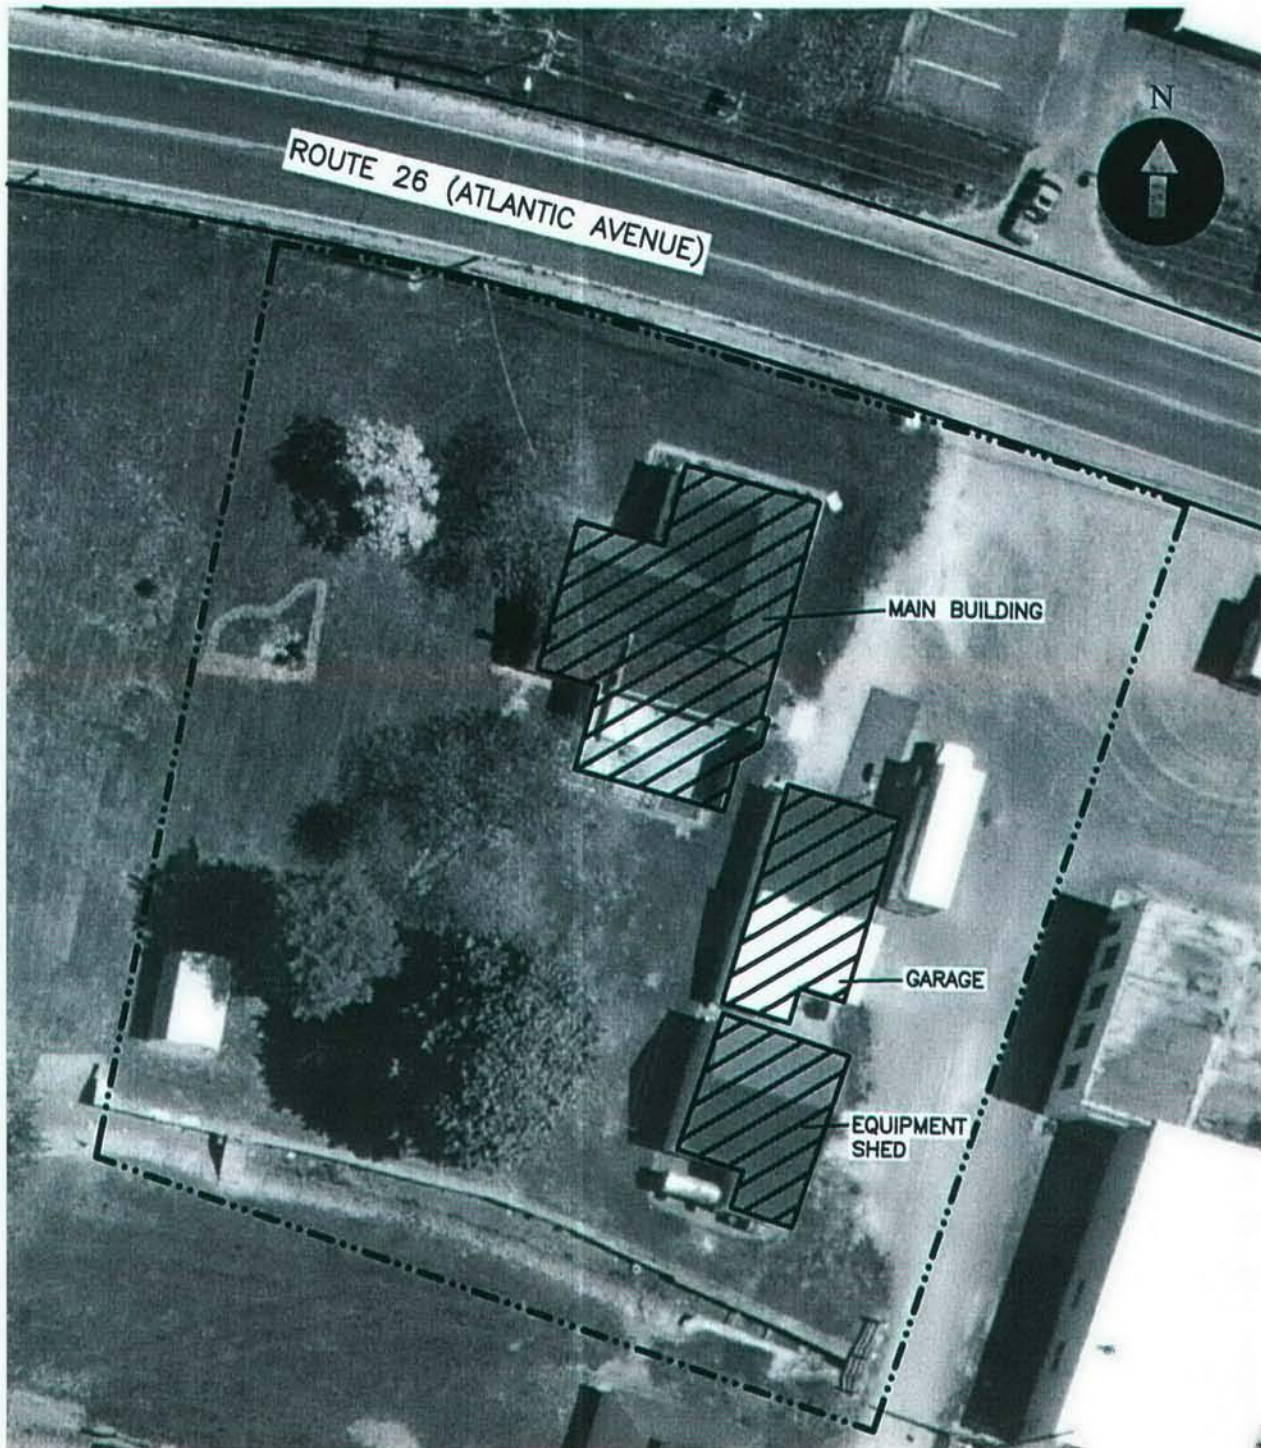
Sketch Plan:

The Franklin and Diane Bennett Property (Tax Parcel 1-34-12-338.00) is a one and one-half story, four bay, aluminum-clad, bungalow with a cross-gable asphalt-shingle roof. The main (north) façade has an enclosed, hipped-roof, one-story porch in the three easternmost bays; it has a central single-leaf entrance with a wood and glazed door and aluminum and glazed storm door flanked by tripartite sets of four-light awning windows. The westernmost bay has a paired vinyl 1/1 window with faux louvered shutters. The gable peak has a vinyl 1/1 window with faux louvered shutters. The east façade has two vinyl 1/1 windows with faux louvered shutters and a single-leaf entrance with a shed roof porch supported by square wood posts. The east façade has a brick façade on a portion of the first

To the southeast of the main house there is a one-story, two-bay, aluminum-clad, garage with a front-gable asphalt shingle roof. The main (north) façade has a single-leaf entrance with a flush door and a single-bay vehicular entrance with a paneled and glazed roll down door. To the rear there is an addition to the garage; it has a corrugated metal shed roof and serves as a single-vehicle carport with an east entrance. The south façade features one opening with a four-light window.

To the south of the main building and the garage there is a one-story, two-bay, aluminum-clad, equipment shed with an asphalt-shingle gable roof. The main (east) façade features a single-leaf entrance with a wood door; to its south there is a double-leaf vehicular entrance with sliding metal doors. The north and south facades are unadorned.

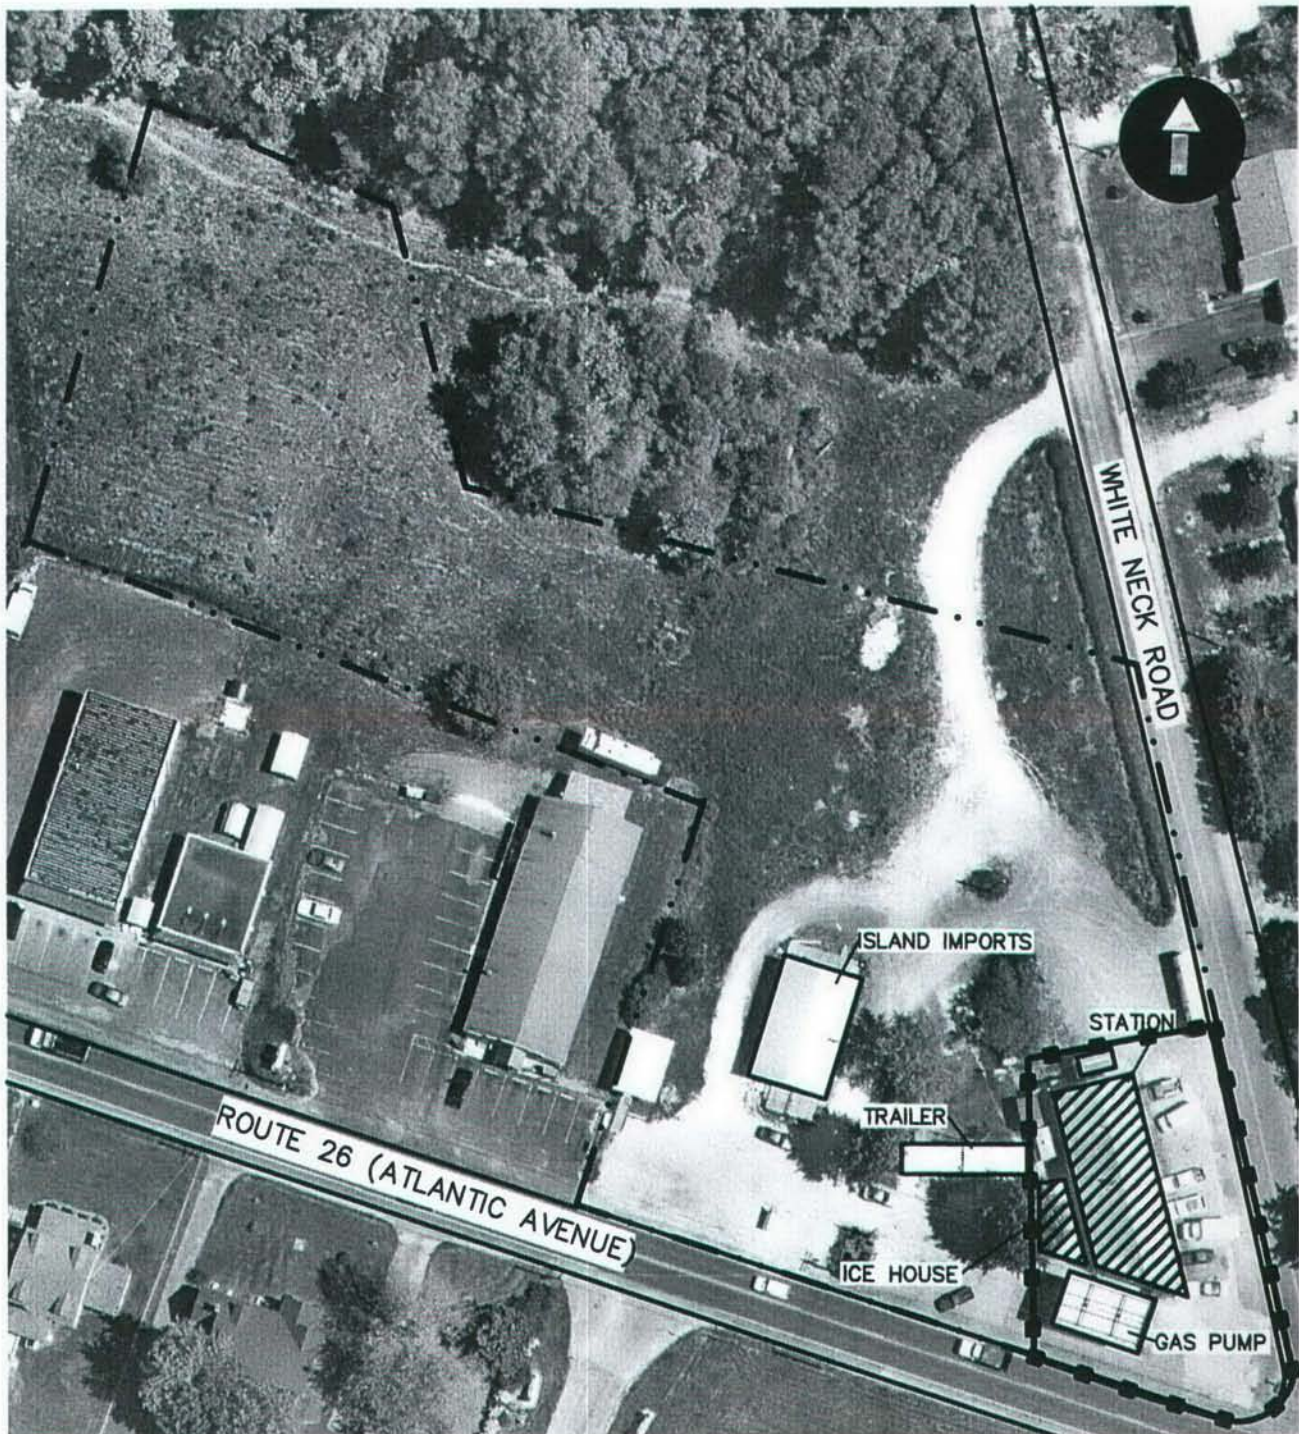
Sketch Plan:

The main building of the Russell Banks Property (Tax Parcel 1-34-12-14.00) serves as a Mobil service station. It is a two and one-half story, four-bay, concrete block, Colonial Revival building with an asphalt-shingle gable roof. The main (south) façade features, moving from east to west, a single-leaf entrance in bay one, two fixed single-light commercial windows in bays two and three, and a single-leaf entrance in bay four. The second story has wood 1/1 windows; the gable also has a wood 1/1 window. The east façade has an irregular fenestration pattern; the south façade has a single-leaf entrance with a flush door to the east and two wood 1/1 windows in the gable peak. This is a contributing feature of the property.

To the west of the main building is a one-story, concrete block, icehouse with an asphalt-shingle, front-gable roof. The main (south) façade has a single-leaf entrance with a flush metal door; the east and west facades are unadorned. This is a contributing feature of the property.

To the west of the main building and icehouse is a trailer. It is one story and five bays wide. Moving from east to west it has louvered windows in bays one and two, a single-leaf entrance in bay three, and louvered windows in bays four and five. Faux shutters flank the windows. There is one louvered window in the west façade and two louvered windows in the north façade.

To the west of the main building there is a one and one-half story, three-bay, aluminum-clad, contemporary commercial building with a corrugated metal front-gable roof. The main façade has a central single-leaf pedestrian entrance with a glazed door flanked by single-bay garage entrances with paneled roll-down metal doors.
